Hidden Head-In-Pillow soldering failures

Abstract

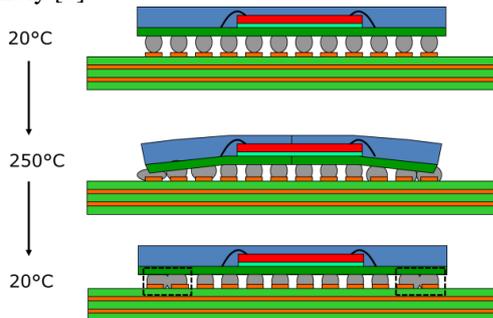
When the package has an excessive **convex** deformation at reflow temperature (Figure 1), the outer solder joints can collapse such that two or more joints form one shorted joint. After cooling down below solder reflow temperature, this joint is frozen in and the component will indicate an electrical failure after assembly [6].

Figure 1: Schematic drawing indicating the impact of convex warpage at reflow temperature leading to shorts between balls

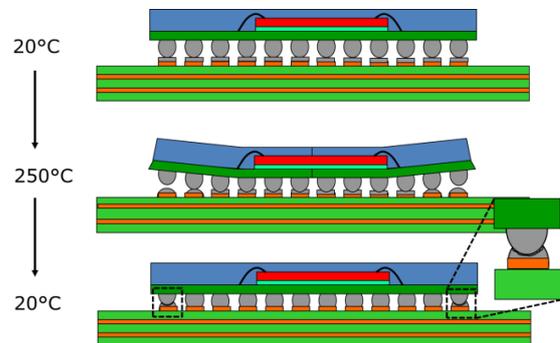
When the package has an excessive **concave** warpage, another soldering failure can be experienced. A too high concave warpage at solder solidification temperature can cause the so-called head-in-pillow where the solder paste deposit wets the pad, but does not fully wet the ball or the liquid solder connection gets disconnected without merging together again prior to solidification (Figure 2). This results in a solder joint with enough of a connection to provide temporary electrical interconnectivity but lacking sufficient mechanical strength (Figure 3). Due to the lack of joint strength, the joint will fail with little mechanical stress. This defect is usually not detected in electrical testing, and typically shows up as a field failure after the assembly has been exposed to some temperature increases where the BGA ball loses from the PCB solder pad due to package warpage.

Figure 2: Schematic drawing depicting the consequences of concave warpage at reflow temperature leading to head-in-pillow failures.

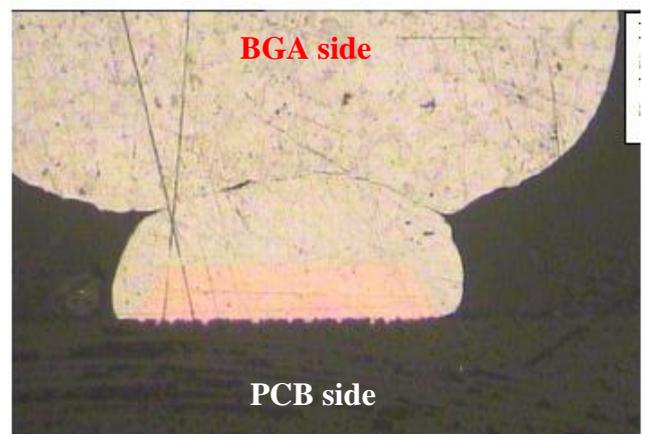
Figure 3: Cross-section visualizing the head-in-pillow BGA joint seen after cooling down from soldering process. It actually looks like a head has pressed into a soft pillow.

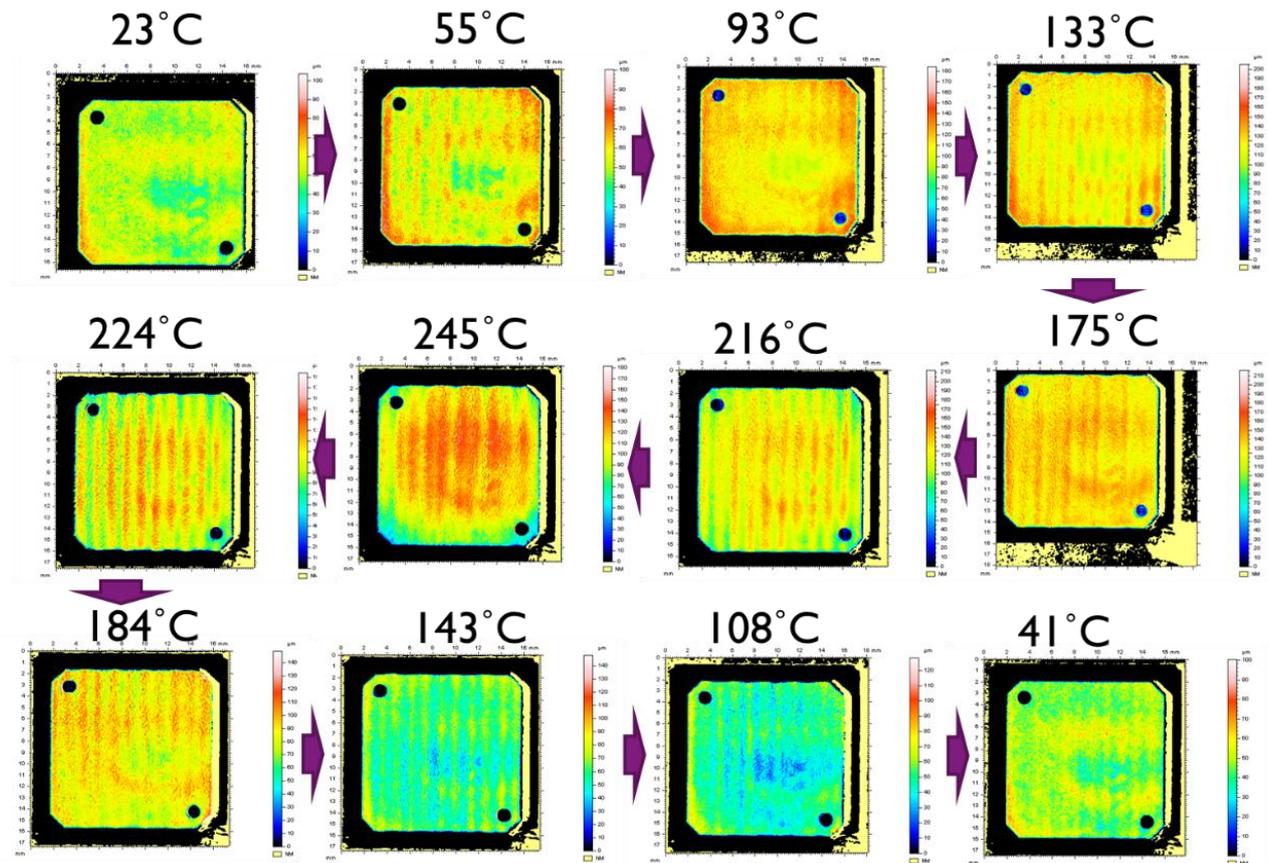
Figure 4 shows the measured out-of-plane profiles of the 17 mm size packages at different temperature stages of the solder temperature profile. It can be seen that the package is rather flat at room temperature and a convex warpage is found in particular above 200°C, with a highest deformation at 245°C.

Figure 4: 3D profile of the 17 mm flexBGA package measured during a solder reflow profile. The package was stored at room temperature being able to take up some moisture

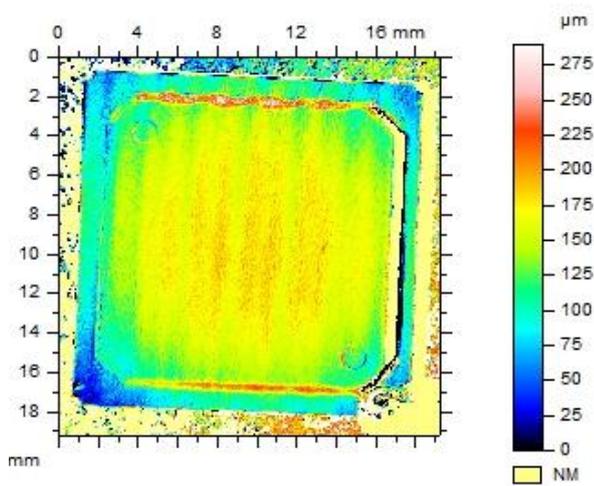
Figure 5 shows the difference between the topography profile at 245°C and at 23°C. The delta graph obviously indicates that this BGA package gets a convex deformation when it is at the highest temperature. The four corners are warping down. Figure 6 shows this out-of-plane deformation over the diagonal. The package warps almost **150 µm** and this explains why the inner balls are having a potential for having the head-in-pillow solder failure.

Figure 5: Difference in z-deformation between 245°C and 26°C. This plot indicates that the package has a convex deformation from room to reflow temperature (17 mm FBGA)

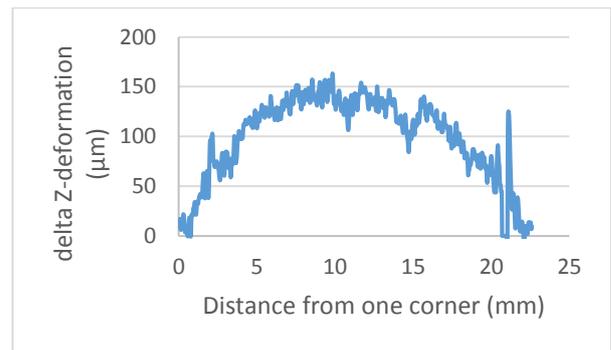
The JEITA ED7306 guideline sets that for package with 1 mm pitch and 0.5 mm ball height, the maximum permissible warpage is 220µm. Taking into account that the board itself also can warp and at room temperature, the flex side is already warped down several tens of microns, the measured warpage comes close this critical value.

Figure 6: Delta warpage between 246°C and 26°C shown over one diagonal (17mm FBGA)

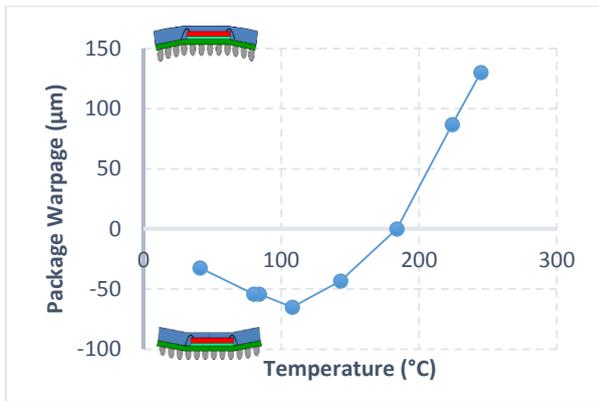
As shown in Figure 7, the convex warpage mainly occurs above 180°C. This is caused by the higher thermal expansion of the mould compound than the expansion of the laminate. The turning point around 110°C is probably related to the glass transition point T_g of the mould compound. Below this T_g , the CTE of the mould compound is lower than the one of the laminate.

Figure 7: Warpage evolution of 17 mm FBGA as function of temperature

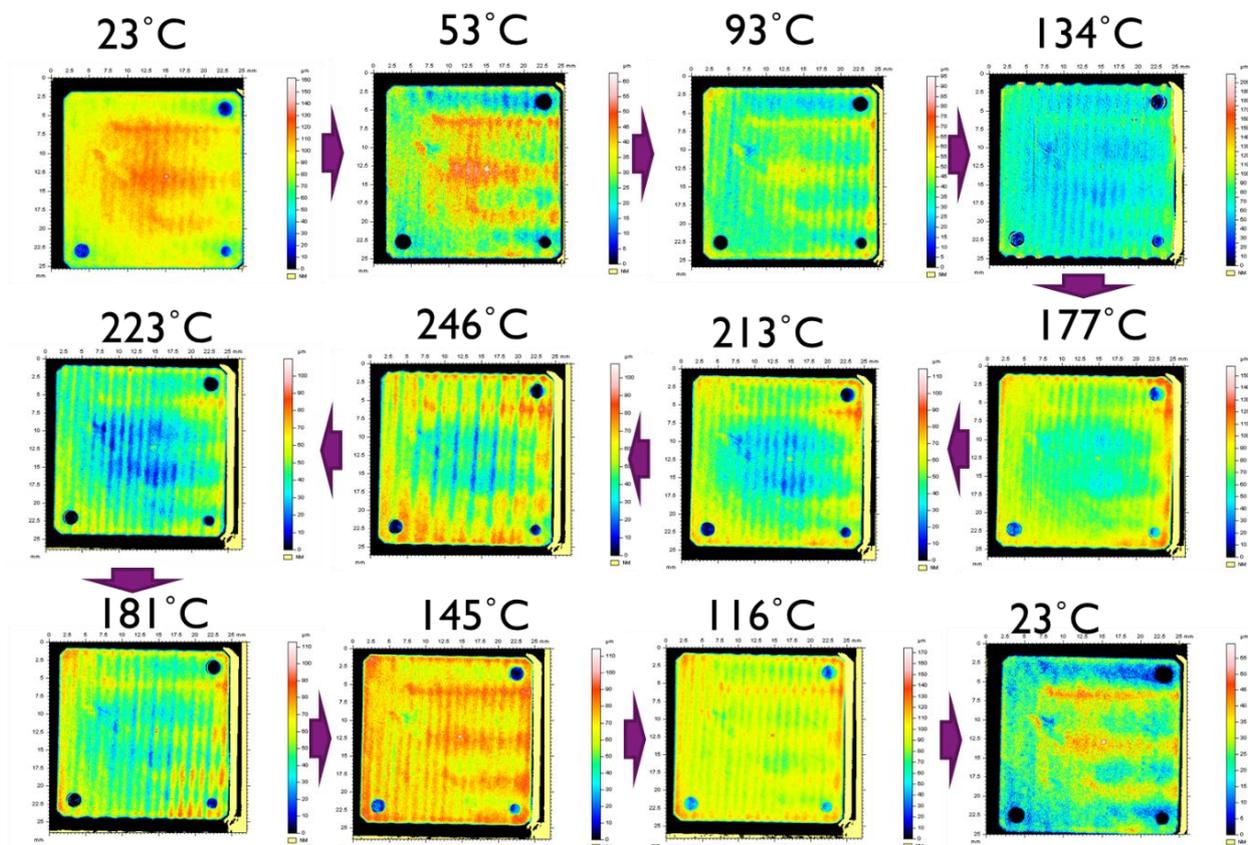
For a 27x27 mm² flex BGA package with 1 mm ball pitch, another kind of “hidden” head-in-pillow was experienced. The non-wetted balls were not found in the inner area like with the 17 mm package, nor at the edge, however, they were found in the third and fourth outer row. Soldering issues for the same package type were also reported by reference [5].

In order to explain this result, the warpage versus temperature measurements were performed on this package with the same measurement approach. The topographies at different temperature stages are shown in Figure 8.

Figure 8: Warpage of the 27 mm FBGA package measured during a solder reflow profile.

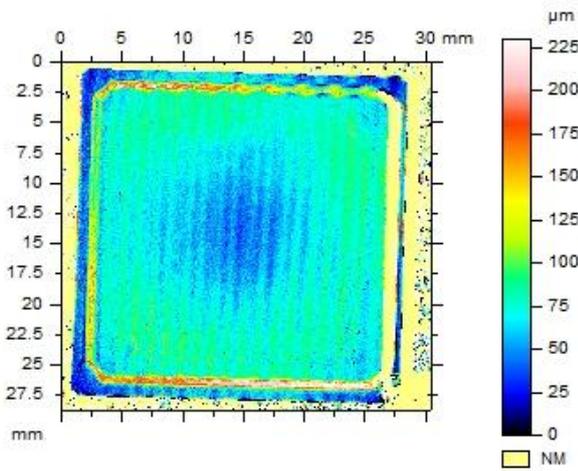
At room temperature, the package has some convex warpage. But at temperatures above solder reflow temperature, the package gets a concave shape. This is however only for the inner area. The edges and the four corners are still warping downward when the temperature rises, as it is indicated in the delta contour plot in Figure 9 and the z-deformation over the diagonal Figure 10.

Figure 9: Difference in z-deformation between 245°C and 26°C for the 27 mm FBGA

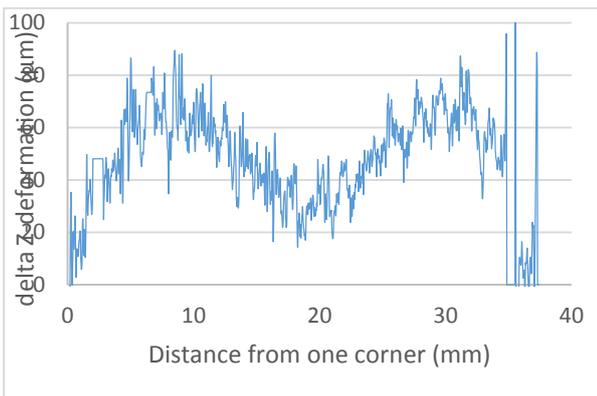
Figure 10: Delta warpage between 246°C and 26°C shown over one diagonal (for 27mm FBGA).

The consequence of such deformation profile at reflow temperature is that at about 3 to 4 mm from the edge, the package is at highest point. With a 1 mm pitch, this means that the third and fourth row of solder joints have the risk to have no contact with the printed circuit board leading to the head-in-pillow issue experienced with this package. This is schematically shown in Figure 11. Taking into account already some initial convex warpage of the package at room temperature and also the outer unmodelled flex substrate which is warping down, we can easily have a height difference of 100 µm between the third and the outer row of solder joints at reflow temperature. This can be sufficient to get the head-in-pillow issue.

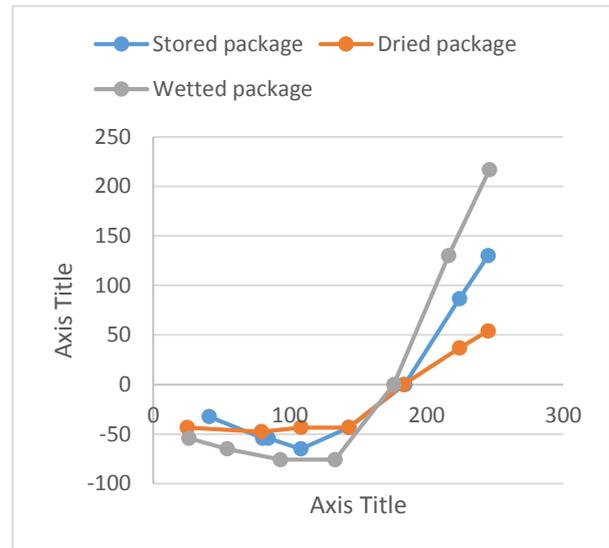
Figure 12 shows the warpage evolution for the three pre-conditions. As expected, the highest warpage was found for the wetted package, the lowest for the dried package. The difference is about a factor 4. The stored sample is lying in between the two curves. Drying these packages before the reflow process gives a reduction of about 2.5 in warpage and probably solves the head-in-pillow issue.

Figure 12: Warpage evolution of 17 mm FBGA as function of temperature.

- although both packages are flex BGA's, the HiP balls are found at different locations: the 17 mm has the highest problems in the center area, the 27 mm FBGA has the HiP balls in the third and fourth outer row
- besides improving solder paste and temperature profile conditions, drying the packages reduces the warpage and the risk for head-in-pillow. The reduction in warpage was a factor 2.5 for the 17 mm FBGA
